SNAG INSPECTION

(FUNCTIONALITY, AESTHETICS, MECHANICAL,
ELECTRICAL & ROOF DIAGNOSTICS)

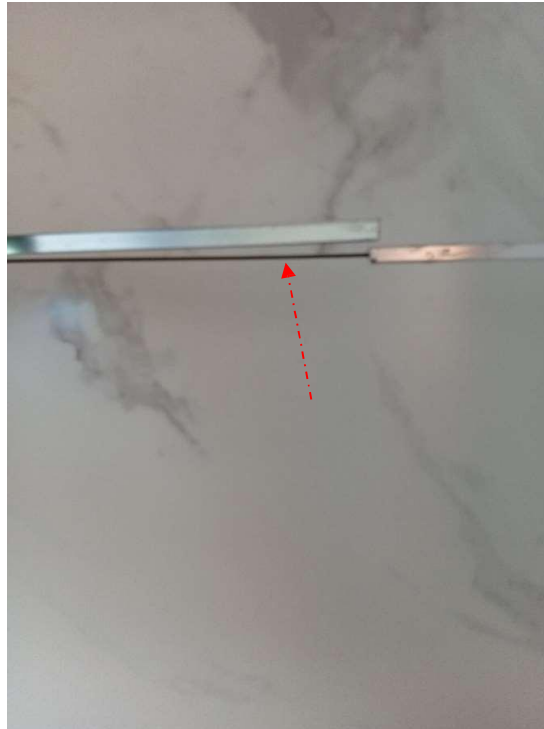
Pic showing: Displacement of metal tile trim / divider due to poor installation or thermal expansion.

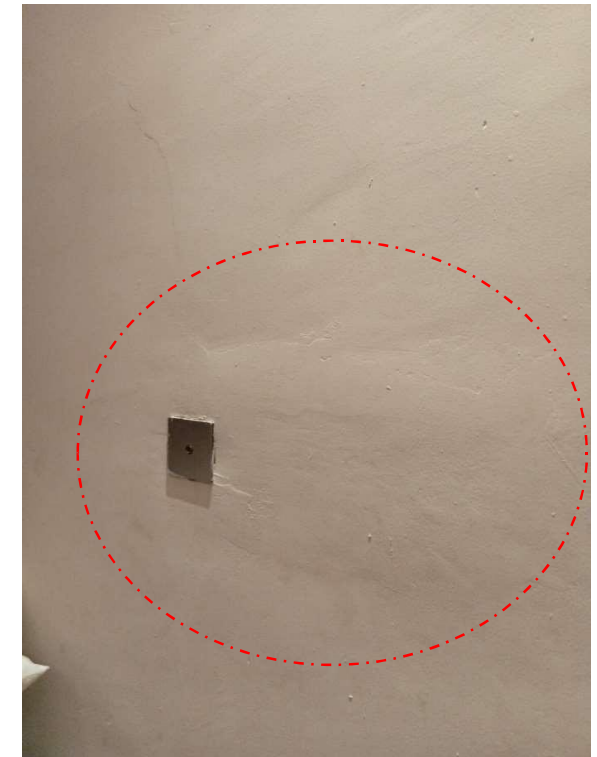
Pics showing: Improper wall rendering caused by poor workmanship.

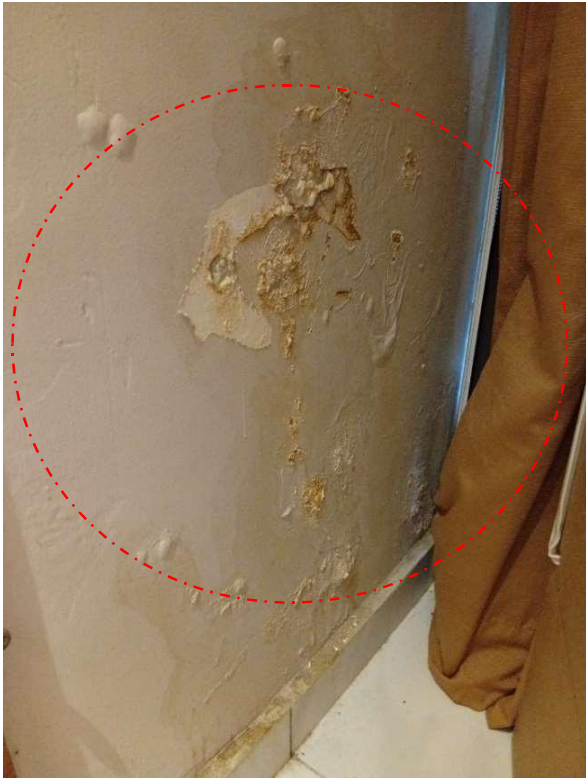
Pics show a severely damp wall with extensive peeling and flaking of paint caused by water ingress from improper tile grout from the toilet behind.

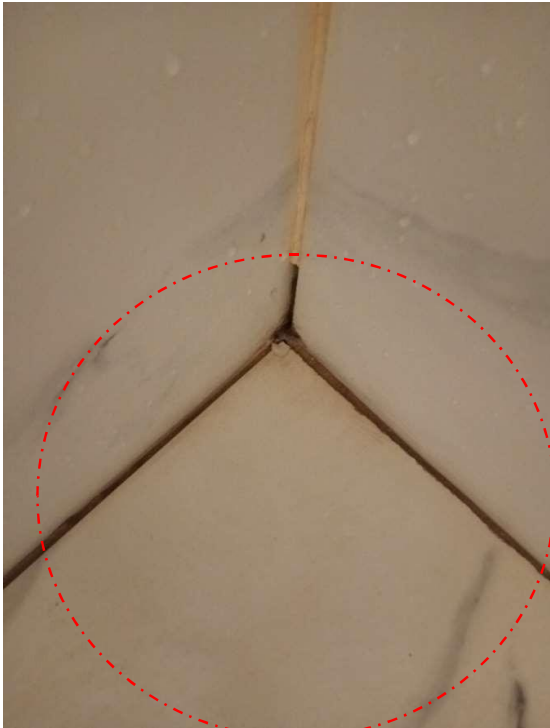
Pic showing: Improper grouting of Toilet tiles, making the wall beneath damp.

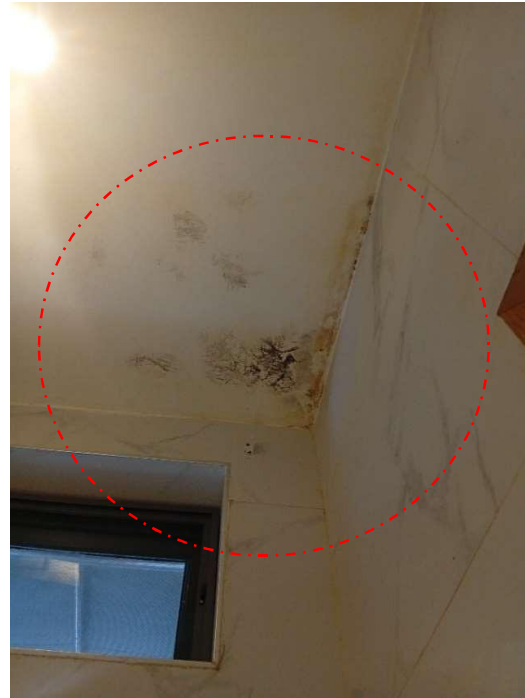
Pic showing: The ceiling exhibits noticeable discoloration, characterized by blackish stains and spots where the pop ceiling material has degraded.

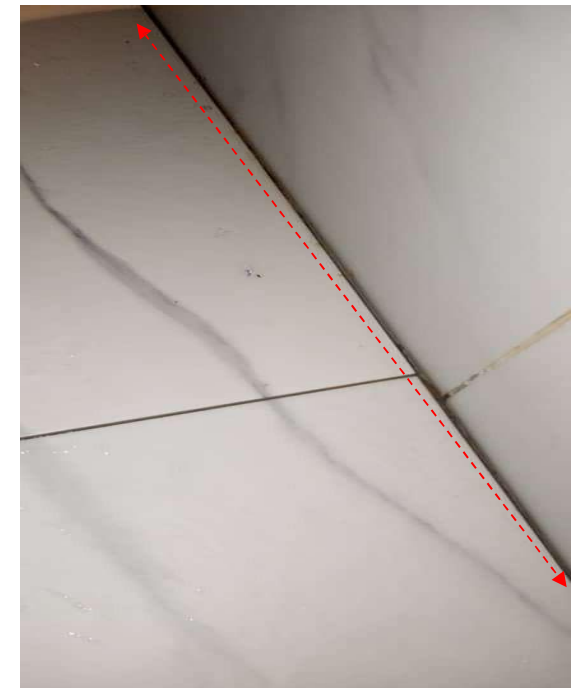
Pic showing: The tiles in the restroom have been improperly grouted, resulting in visible gaps and compromised sealing between the tiles. This substandard application may lead to water infiltration and potential damage to the underlying surfaces.

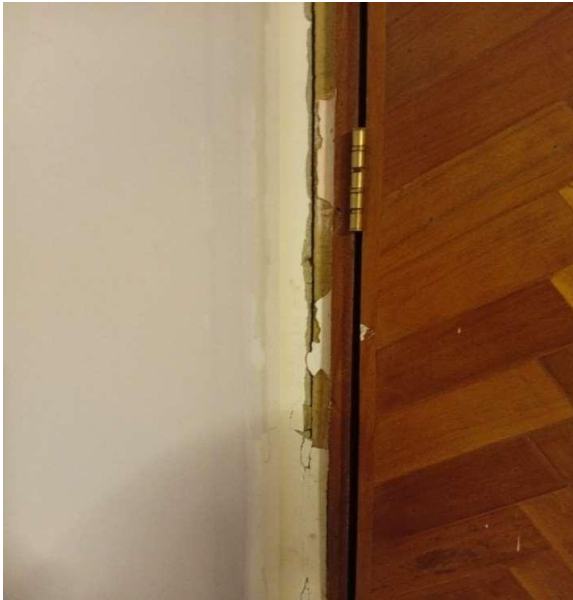
Pic showing: Improper use of wooden doors at toilet entrance, water coming from the bath area can get the door soaked, causing damage to the wooden door.

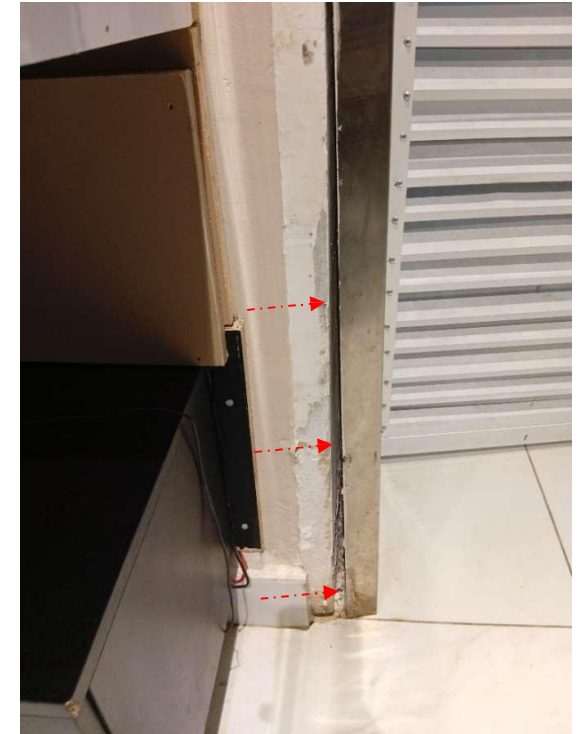
Pics showing detached metallic architrave sealing around the kitchen wall edge opening.

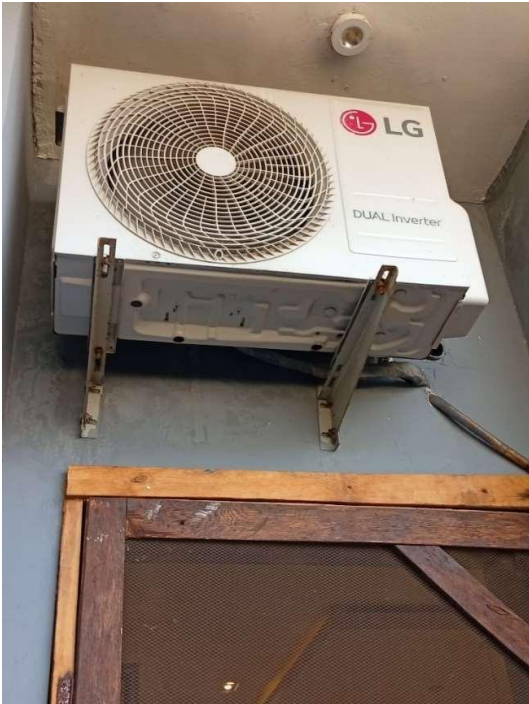
Pics showing the outdoor unit of the air conditioning system discharges water at the rear exit door, which may be an inadvertent occurrence.

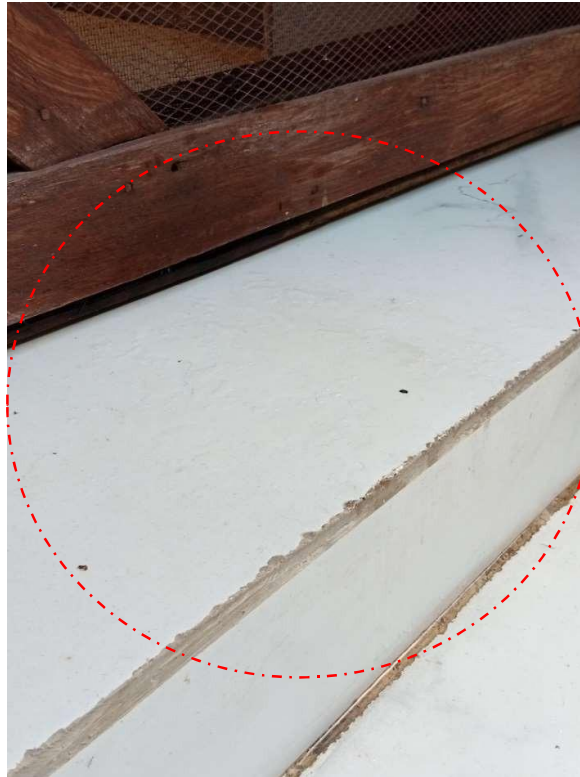
Pics showing water consistently dripping from the outdoor unit of the air conditioning system located near the kitchen exit door. This condition poses a potential slip and fall hazard.

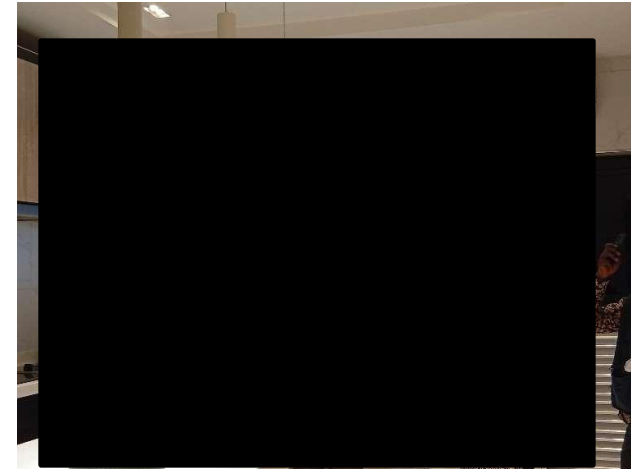
Pics showing good artificial lighting of the kitchen space, but not too good on natural lighting, as the window appears relatively too small to illuminate the kitchen space in case of an electrical power failure.

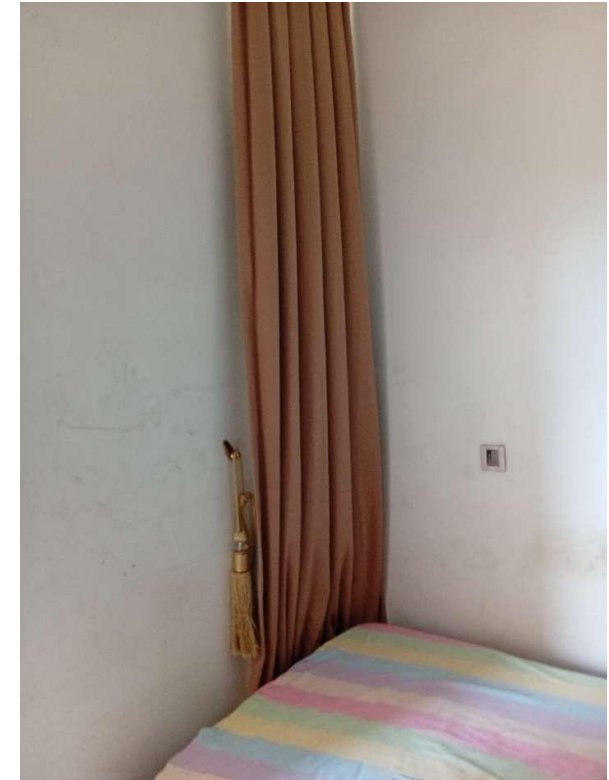
Pics showing a small window size, causing poor ventilation and poor natural lighting in the room.

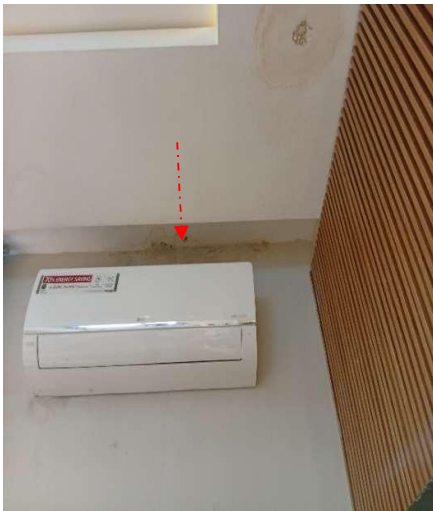
Pic showing the visible appearance of Pop discolouration due to water leakage from the Master bedroom terrace

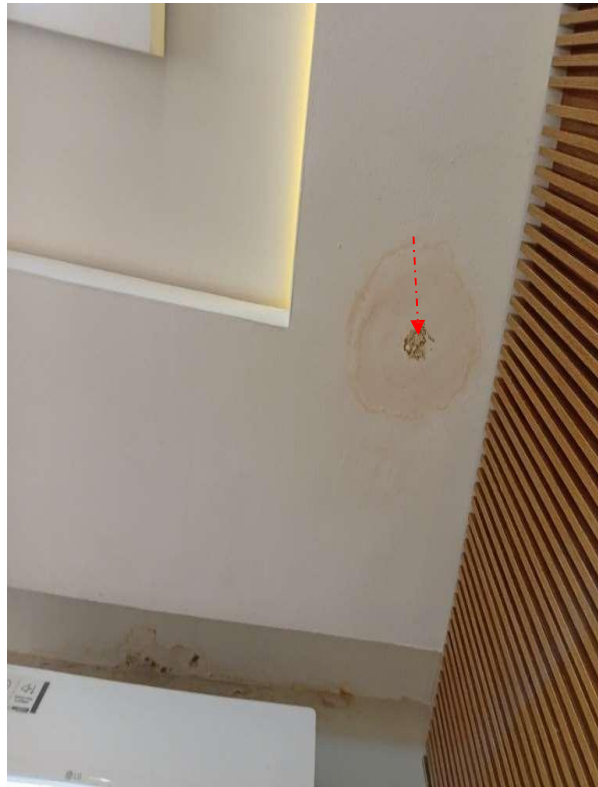
Pic showing the visible appearance of Pop discolouration due to water leakage from the Master bedroom terrace

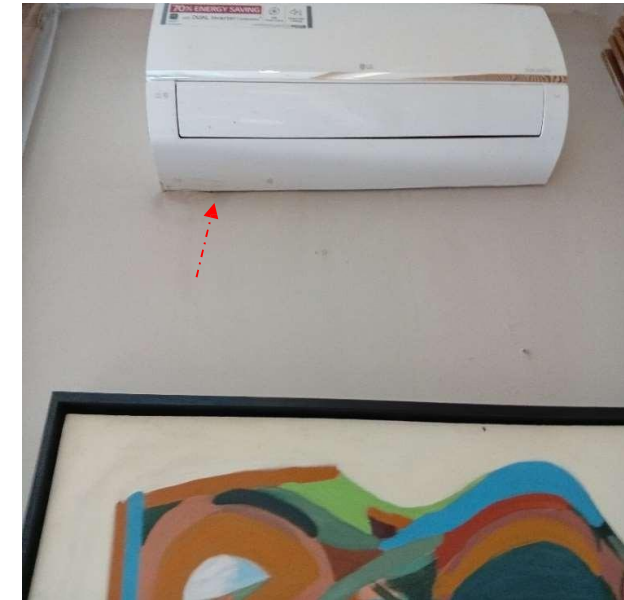
Pic showing: Mechanical Fault on the AC Unit, water leakage under the AC unit.

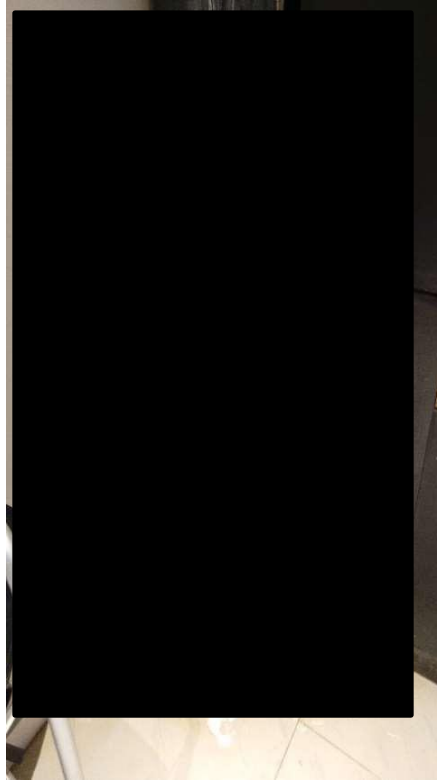
Pic showing: Water staining, damp patches, discoloration, and rusting at the base of the door/ frame caused by water seepage from the terrace of the master bedroom

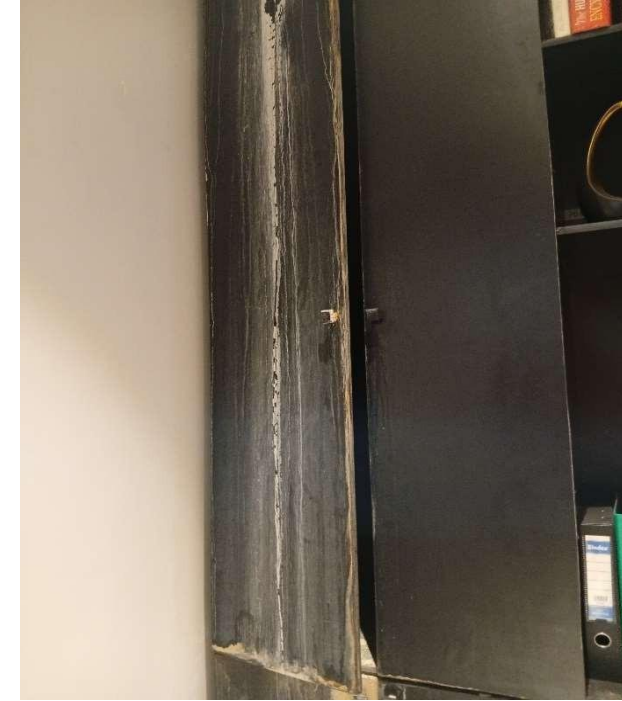
Pic showing: Damaged office wardrobe due to water leakage from the master bedroom open terrace floor.

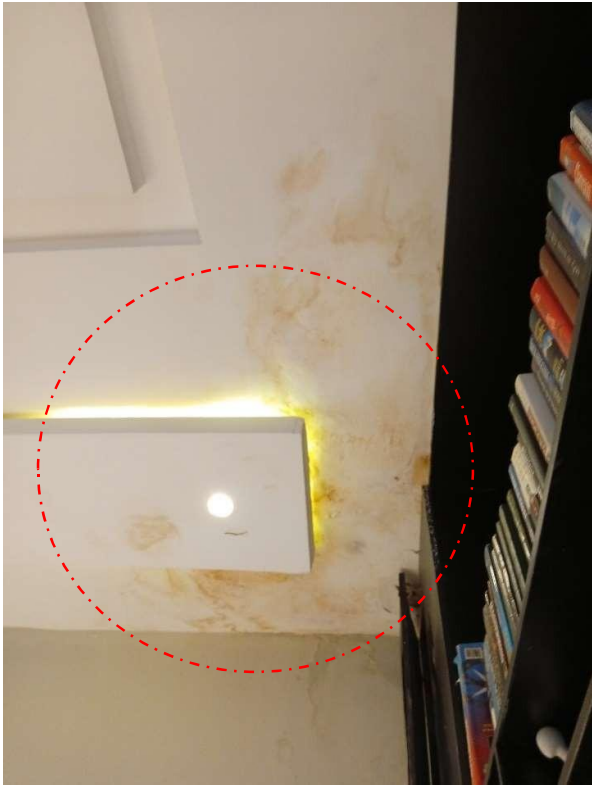
Pic showing: Pop discoloration due to water leakage from the master bedroom open terrace floor.

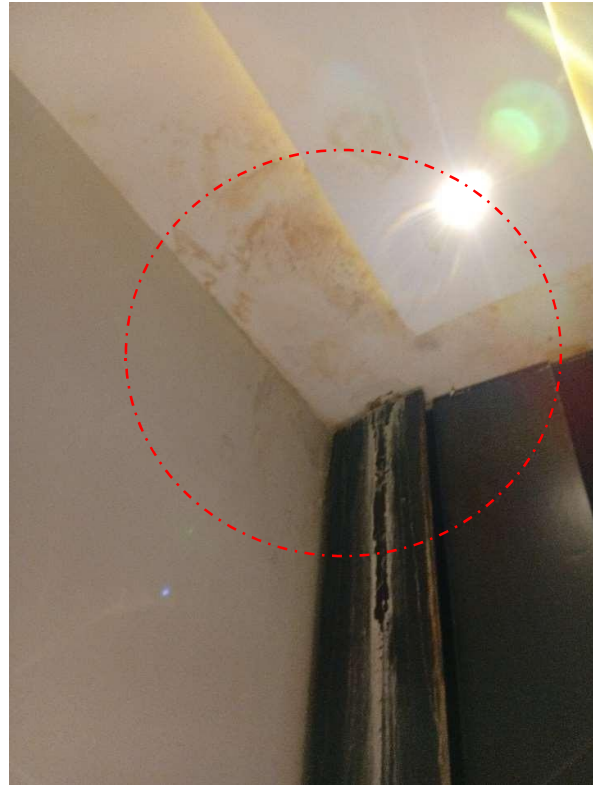
Pic showing: Pop discoloration due to water leakage from the master bedroom open terrace floor.

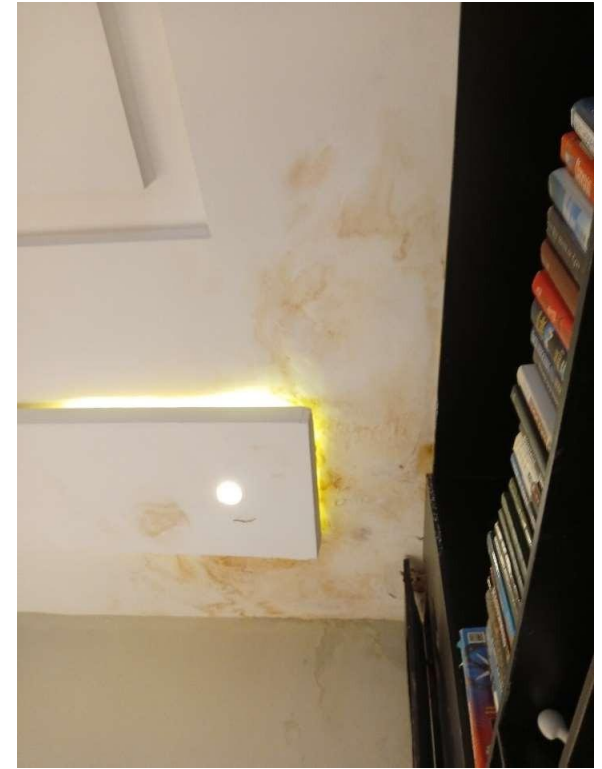
Pic showing: Pop discoloration due to water leakage from the master bedroom open terrace floor.

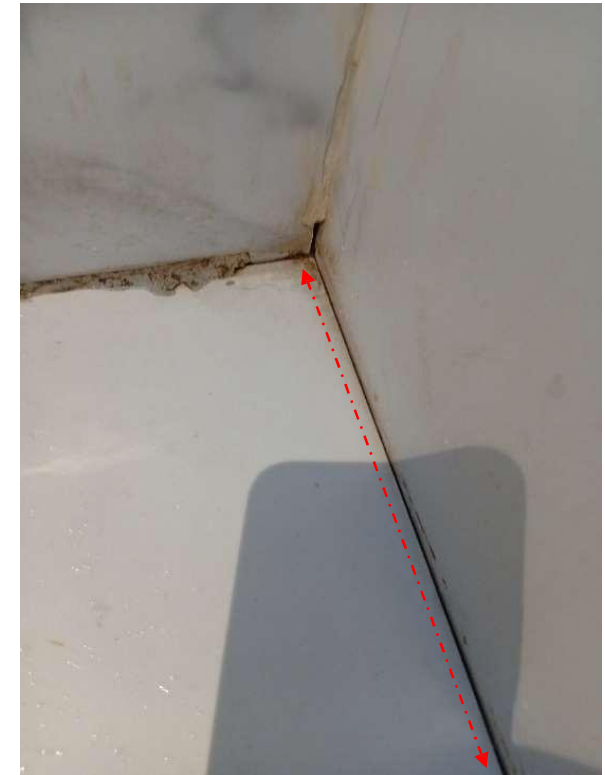
Pic showing: Improper grouting of both the wall tiles and floor tiles, which can lead to dampness of the wall.

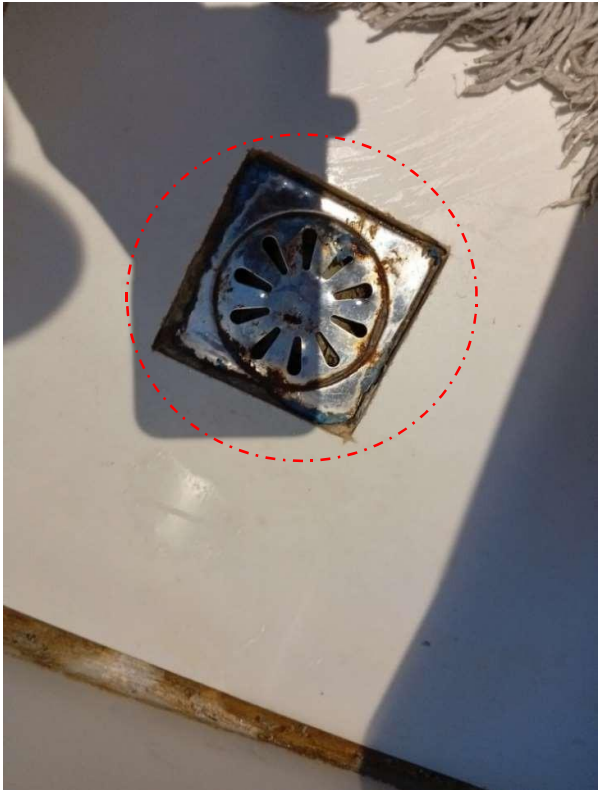
Pic showing: The floor drain is positioned lower than the surrounding tiles, which allows water to seep into the floor. This can lead to dampness in the walls as moisture accumulates over time.

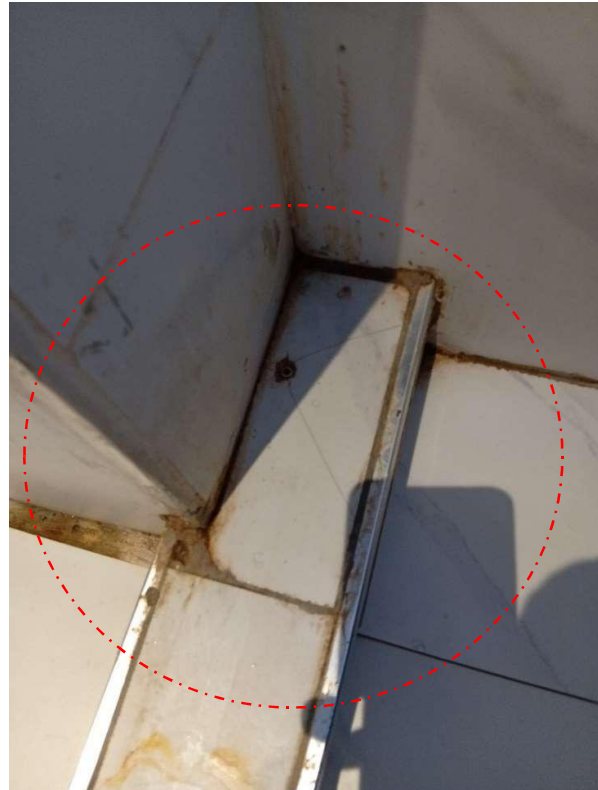
Pic showing: Improper grouting of tiles, mainly along the floor and wall edges, which can lead to dampness of the wall

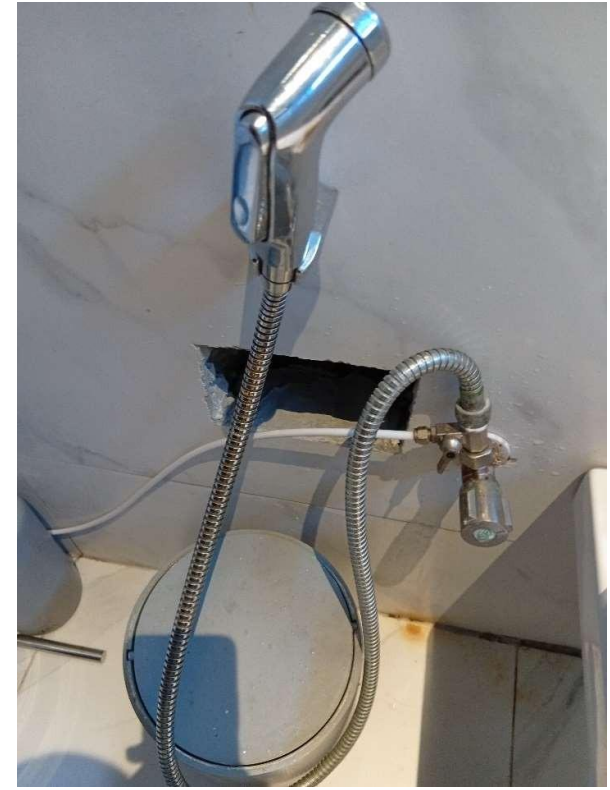
Pics showing uncovered holes in the bathroom with a high moisture zone prone to dampness.

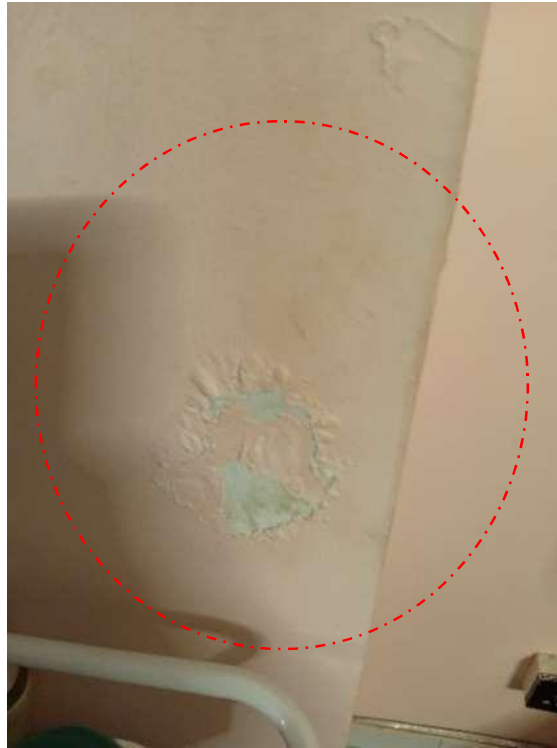
Pic showing an image illustrating a significant concentration of dampness, accompanied by extensive peeling and flaking of finishes, which have been caused by water intrusion from the bathroom.

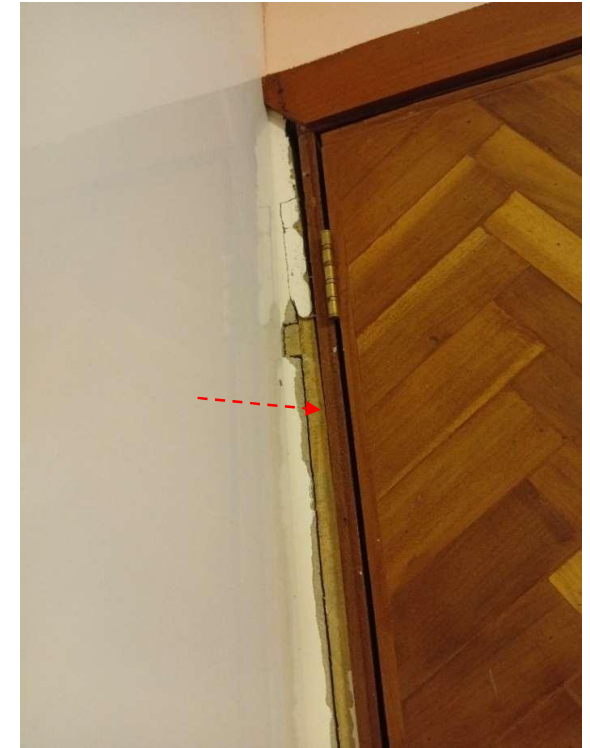
Pic showing: There exists an uneven clearance between the door and the frame, indicating that the door may be misaligned, either being out of plumb or exhibiting warping.

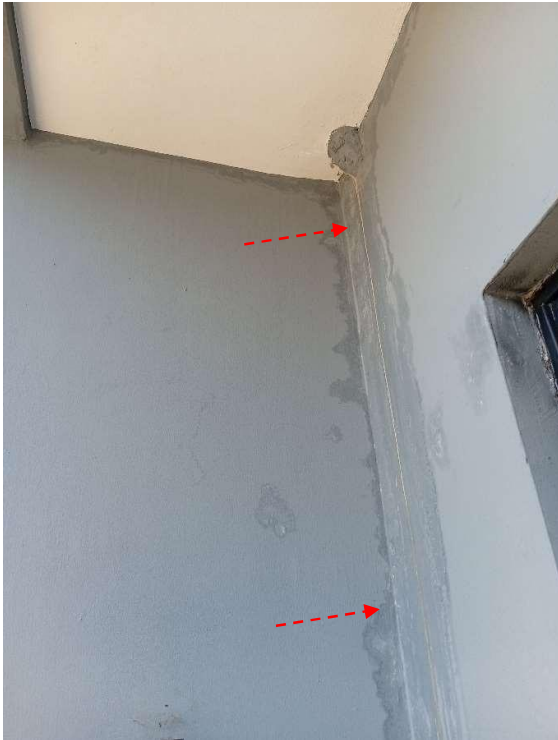
Pic showing damped conduit wall leakage from the 4-inch master bedroom soil pipe down to the duct below.

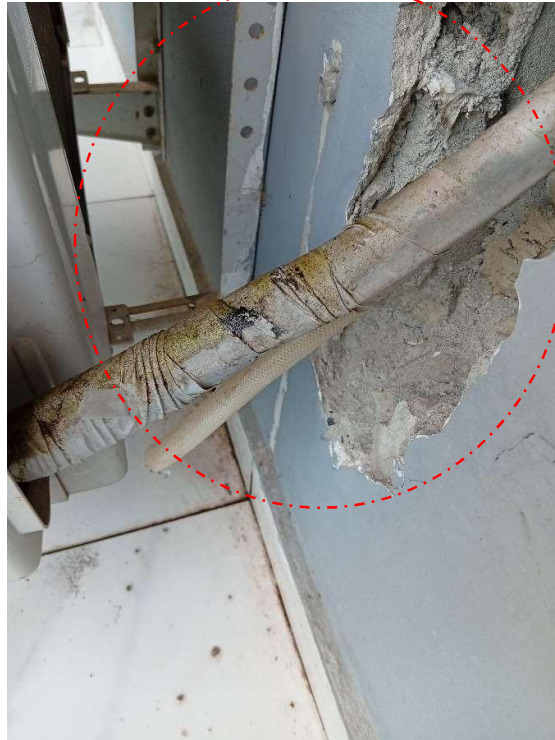
Pic showing improper mechanical AC ducting of the outdoor unit without appropriate sealing, thereby creating openings for rodents and bad aesthetics.

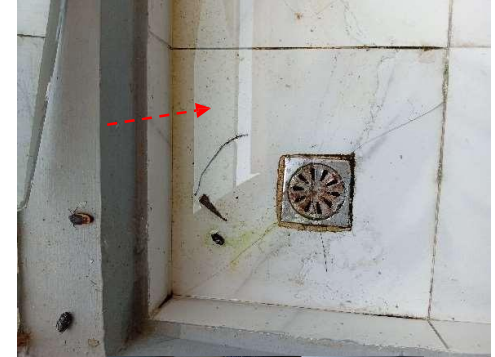
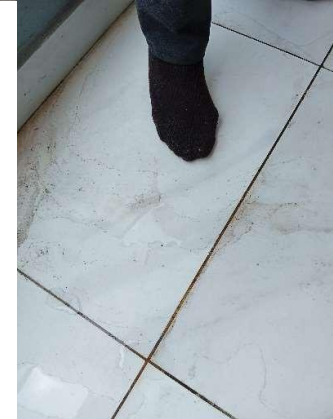
Pic showing water spillage from the outdoor AC unit, thereby creating constant water stagnation on the terrace floor.

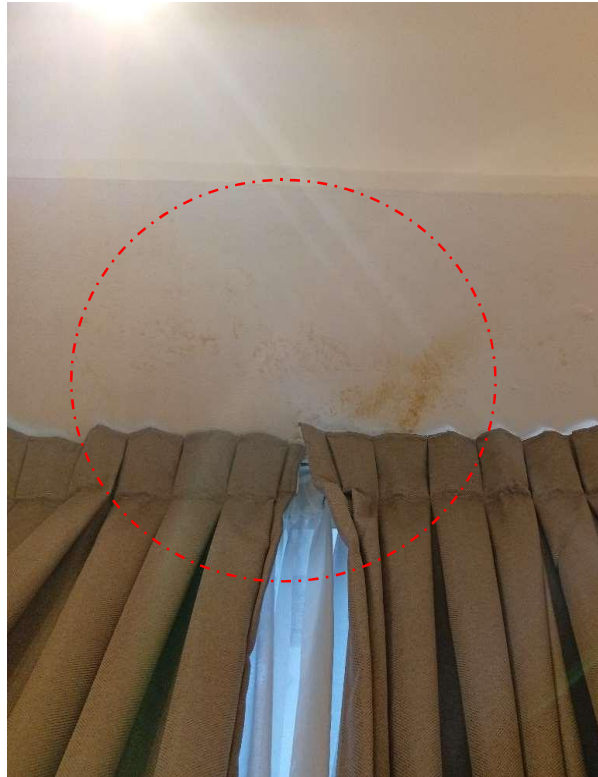
Pics showing: Pop discoloration due to water leakage from the master bedroom open terrace floor.

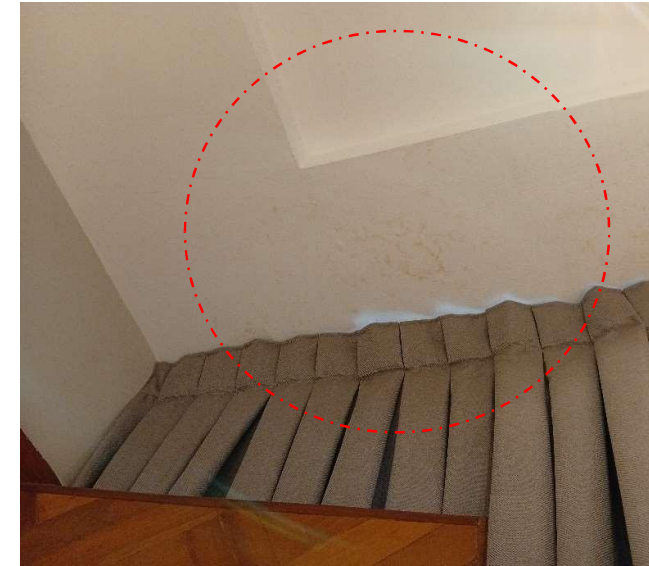
Pics showing: Pop discoloration due to water leakage from the master bedroom open terrace floor.

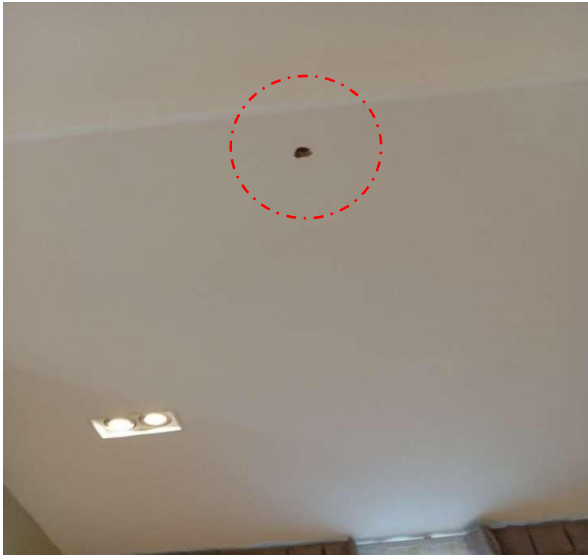
Pic showing: The presence of punctured holes in the plaster of Paris (POP) ceiling board may suggest deficiencies in the quality of finishing, workmanship, and board thickness.

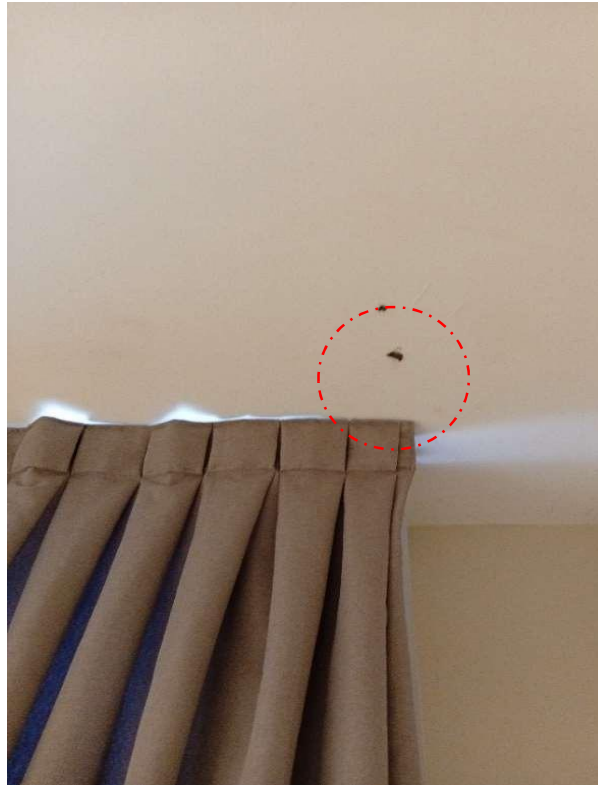
Pic showing: Punctured holes on the Pop ceiling board may indicate poor finishing or workmanship quality.

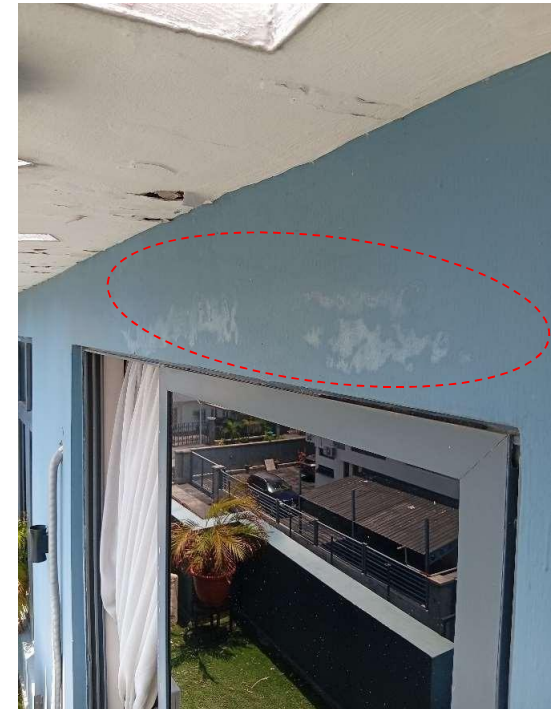
Pic showing: Visible dampness efflorescence beneath the master bedroom concrete slab wall.

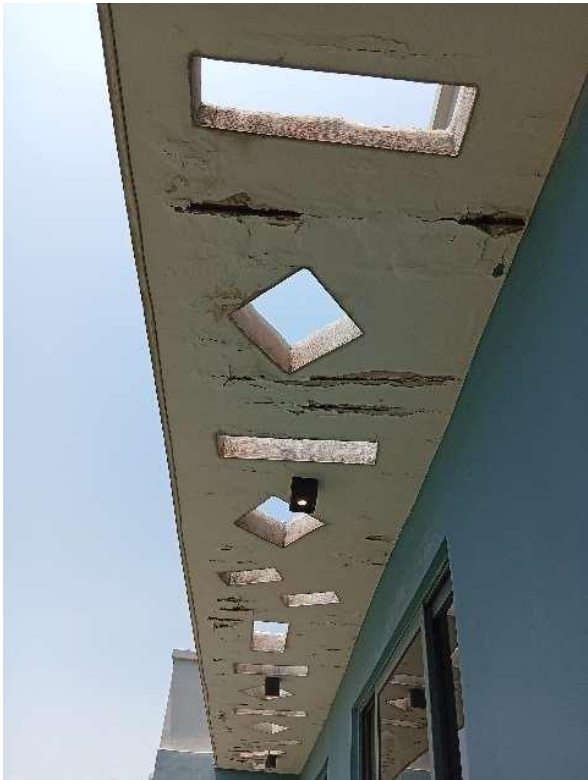
Pic showing: Badly damaged spalling on the concrete slab covering of the open terrace of the master bedroom.

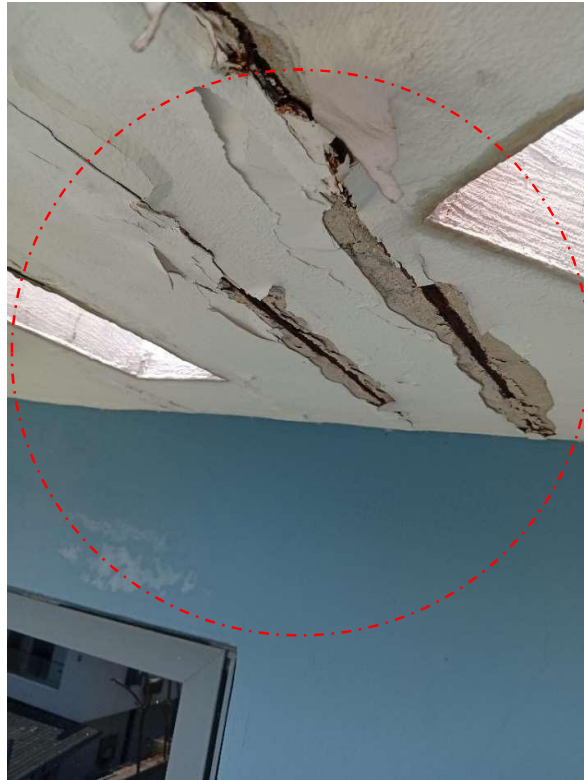
Pic showing: The exposed deterioration of steel reinforcement rebars is attributable to insufficient concrete cover beneath the flooring.

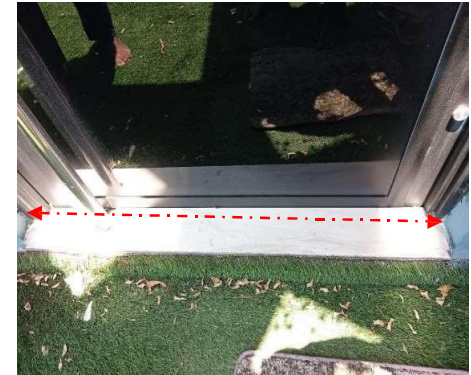
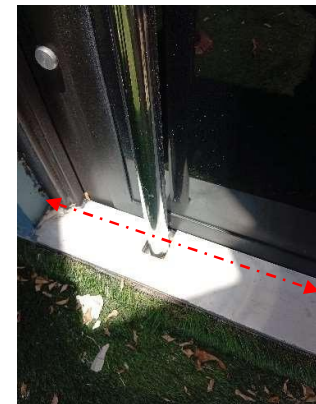
Pic showing: Improper door sealing and roof cover to prevent rainwater seepage during heavy downpour.

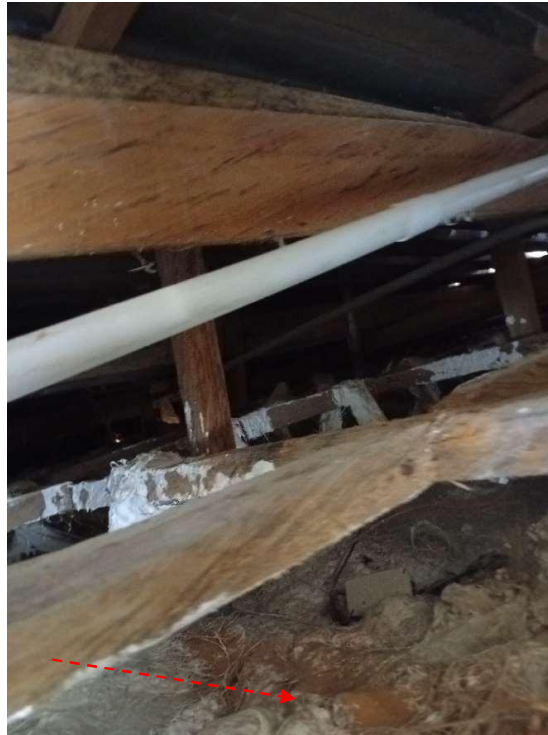
Pic showing: The wood members of the roofing systems being attacked by termites, causing the wood to deteriorate and lose its strength.

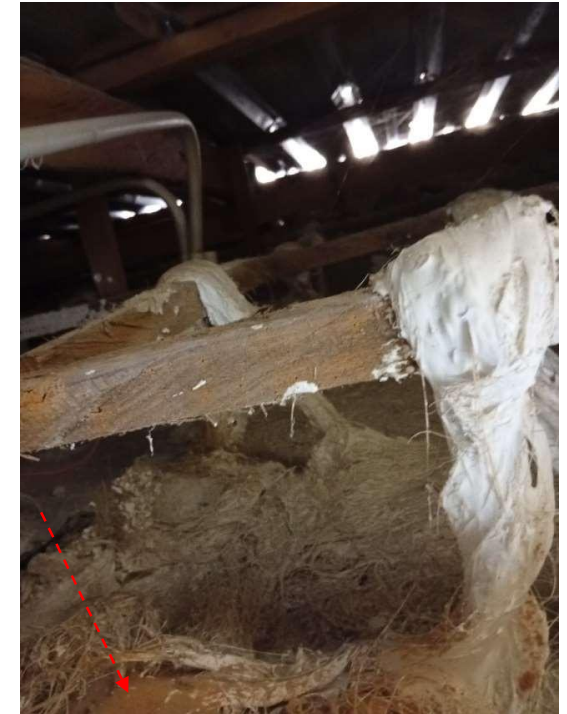
Pic showing: The wood members of the roofing systems being attacked by termites, causing the wood to deteriorate and lose its strength.

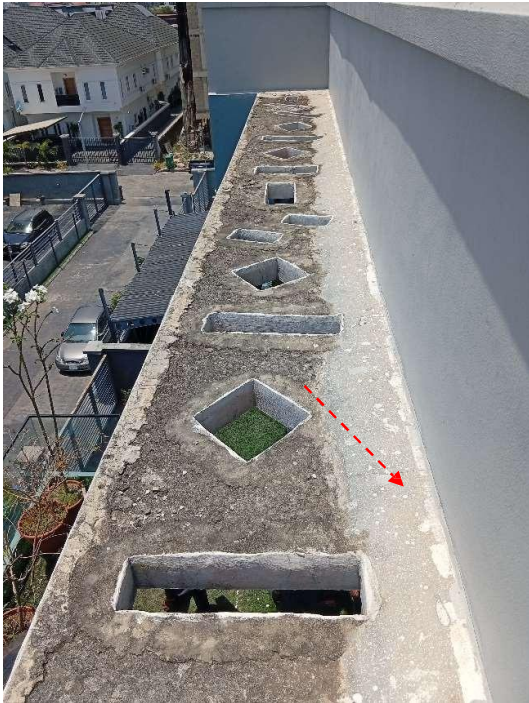
Pics showing a poorly cast afterthought roof slab, sand, and cement patch characterized by multiple porous holes, which have permitted water ingress into the underlying floor slab. This condition has consequently compromised the structural integrity of the slab.

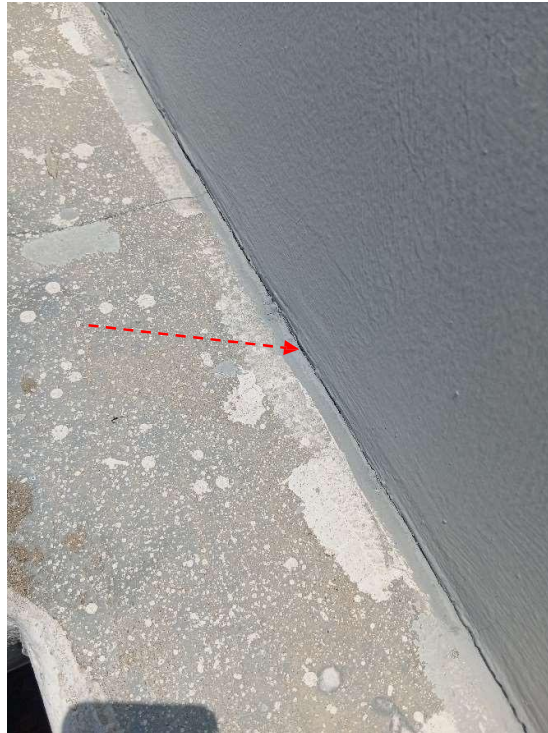
Pic showing visible cracks along the edge of the roof slab and wall, which can be attributed to a failure to achieve proper bonding and a deficiency in waterproofing measures to prevent water ingress.

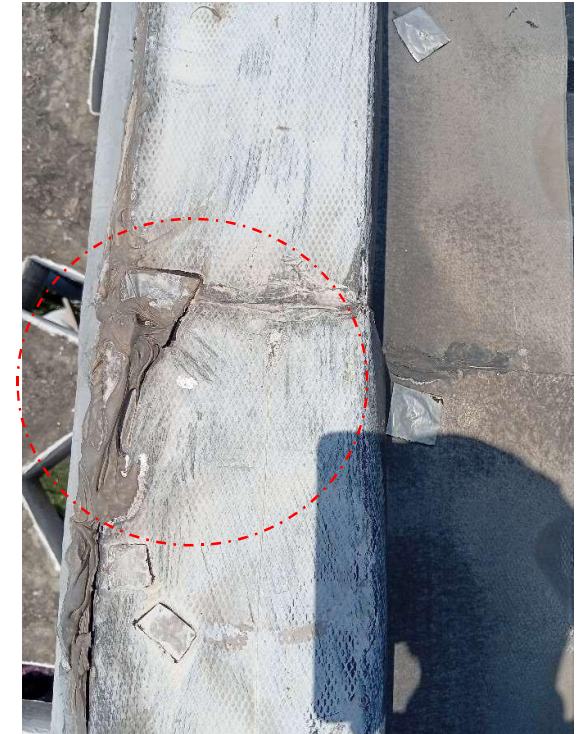
Pic showing repaired roof cap flashing; however, it still contains porous openings that may permit water infiltration into the adjacent block wall.

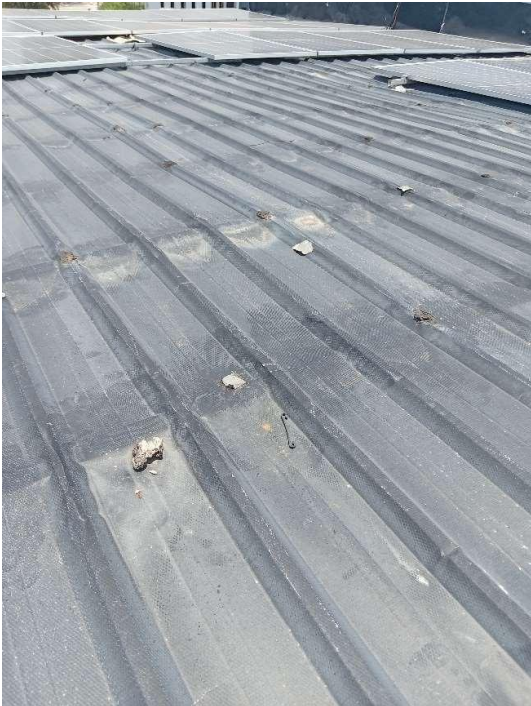
Pics showing a dent on the roofing sheet because of footsteps on the roofing sheet, mainly during solar panel installation.

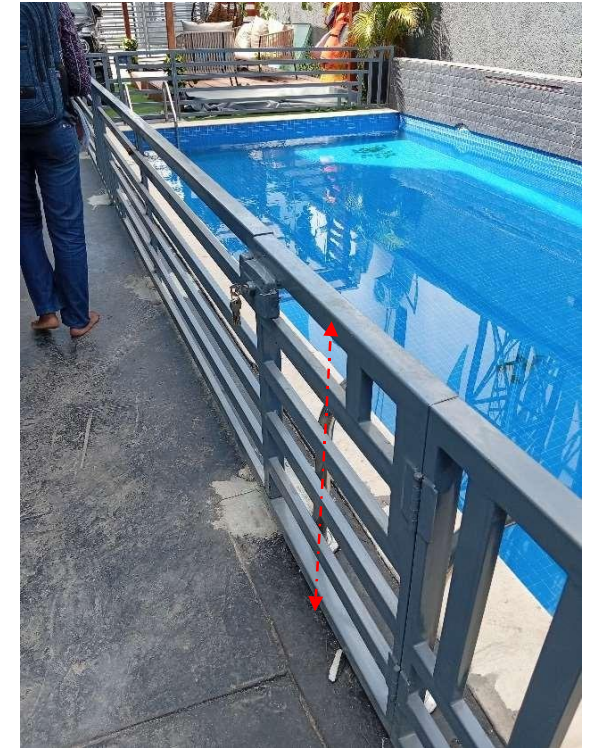
Pic showing: Swimming guard rails, which ought to be vertical to prevent children from climbing to gain access into the pool restricted area.

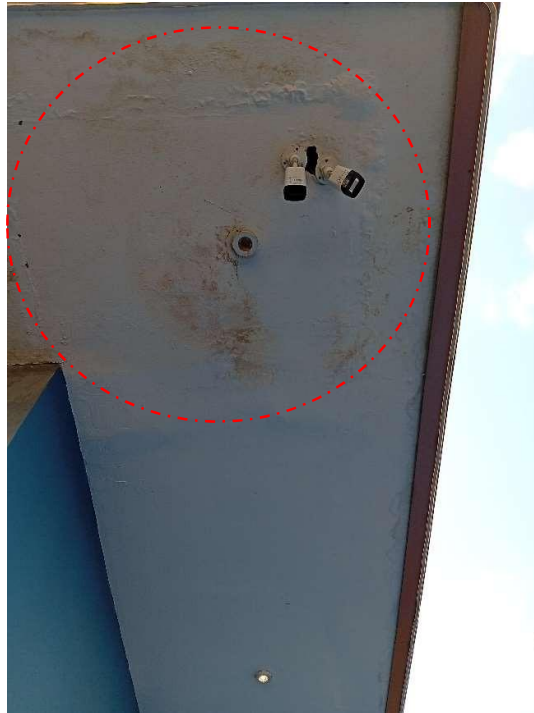
Pic showing: Visible leakage on the cantilevered floor deck, with signs of discoloration from water ingress on the terrace.

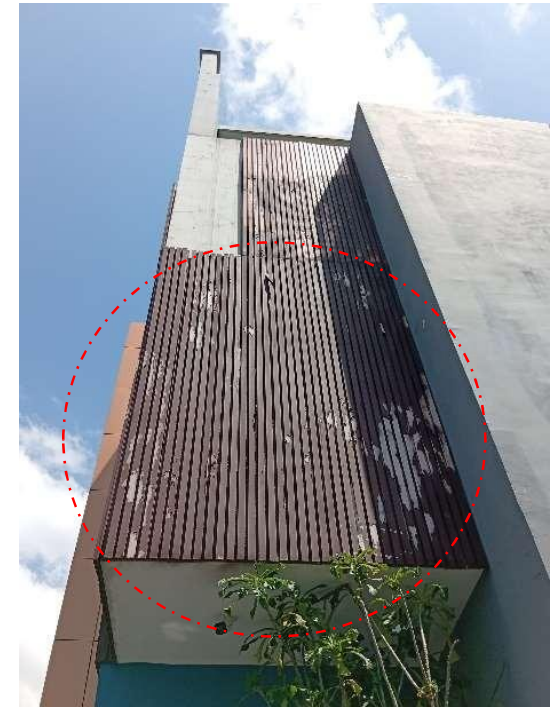
Pic showing: The exterior cladding fluted panels are all worn out due to severe weather conditions, causing the building to lose its aesthetic value.

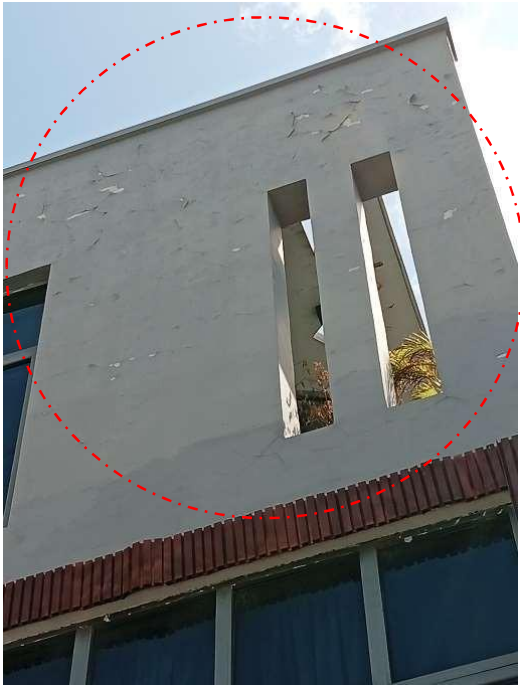
Pic showing widespread peeling of the exterior paint layer, especially on the upper facade.

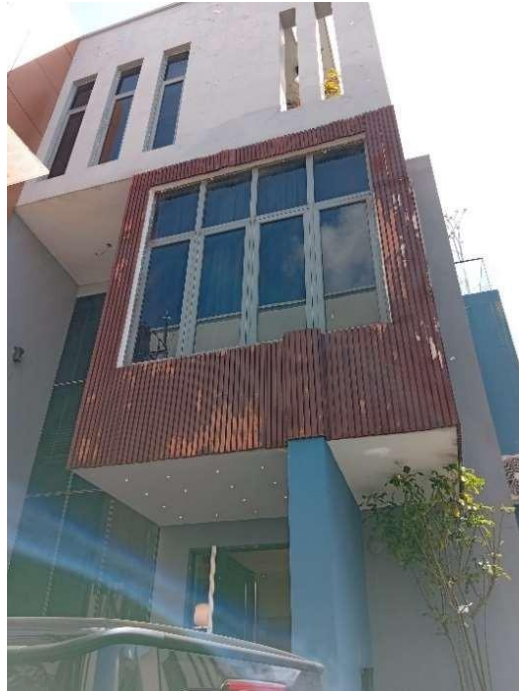
Pic showing the exterior cladding fluted panels are all worn out due to severe weather conditions, causing the building to lose its aesthetic value.

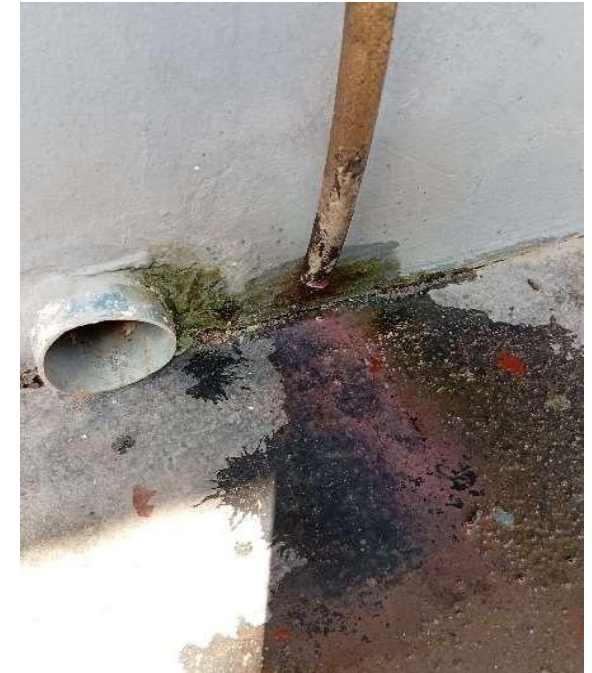
Pics showing water discharge from Ac outdoor unit making the wall edges turn greenish.

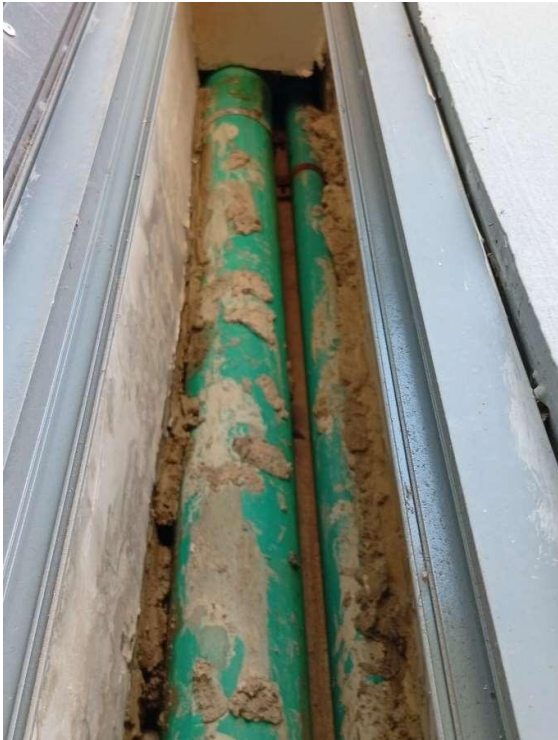
Pics showing an extremely damped 4'' pipe and duct wall, mainly observed to be leaking from the union connector on the upper floor.

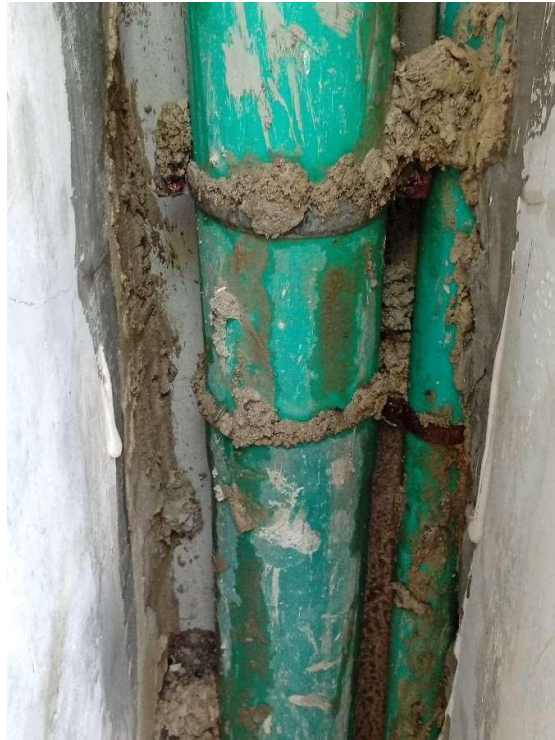
Pics showing an extremely damped 4'' pipe and duct wall, mainly observed to be leaking from the union connector on the upper floor.

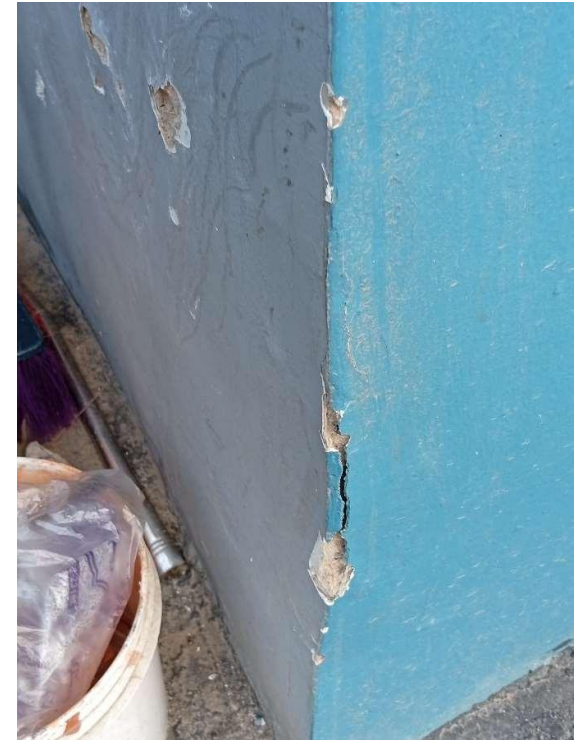
Pics showing flaky walls from the base foundation attributed to rising damp or general leakage soaked up in the floor beneath.
