SNAG INSPECTION

(FUNCTIONALITY, AESTHETICS, MECHANICAL,
ELECTRICAL & ROOF DIAGNOSTICS)

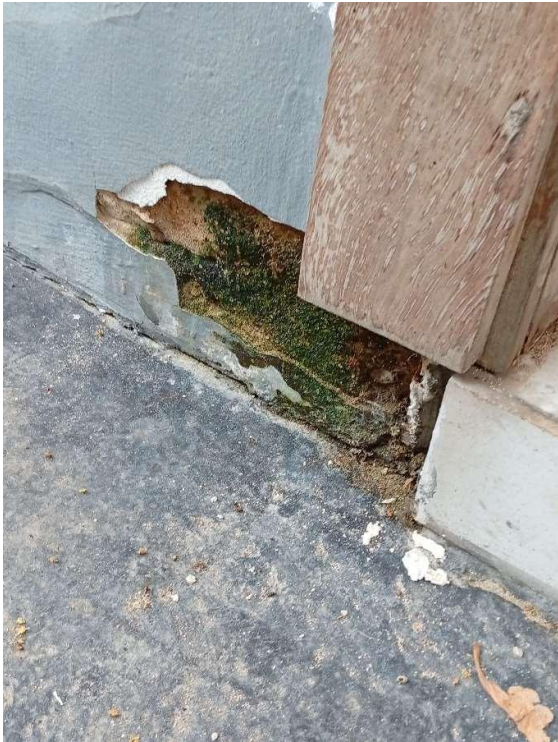
Pics showing flaky walls from base foundation attributed to severe rising damp.

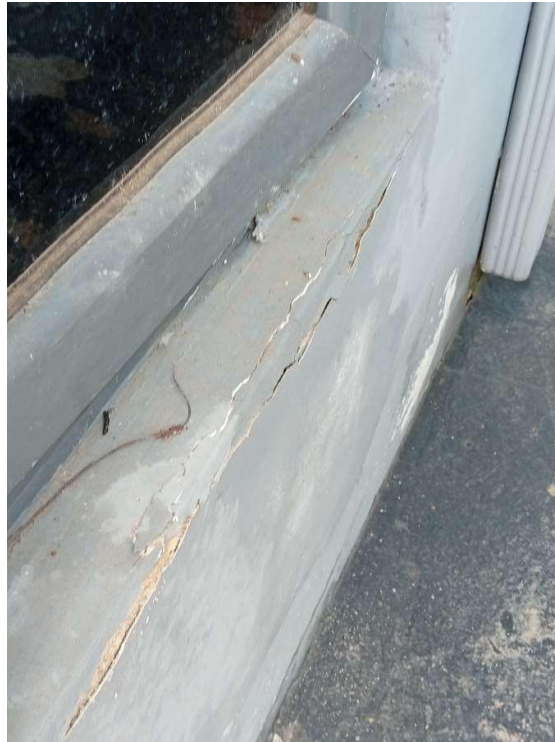
Pics showing flaky walls from base foundation attributed to severe rising damp or water intrusion.

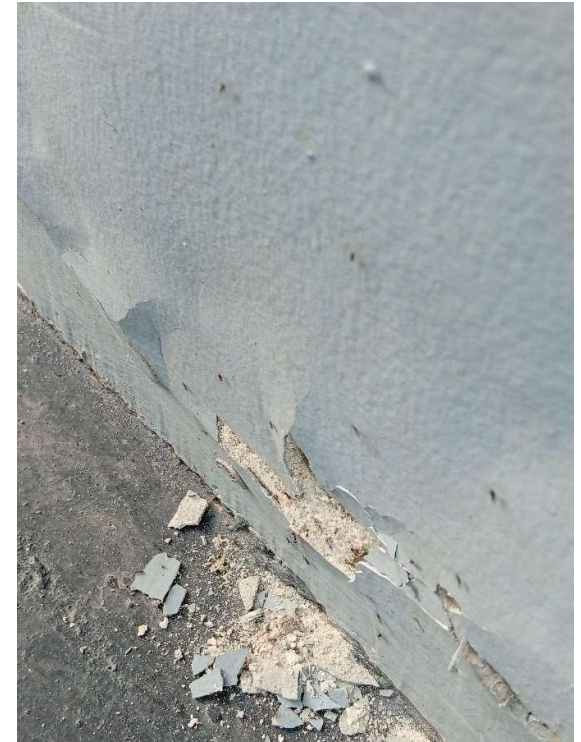
Pics showing flaky walls from base foundation attributed to severe rising damp.

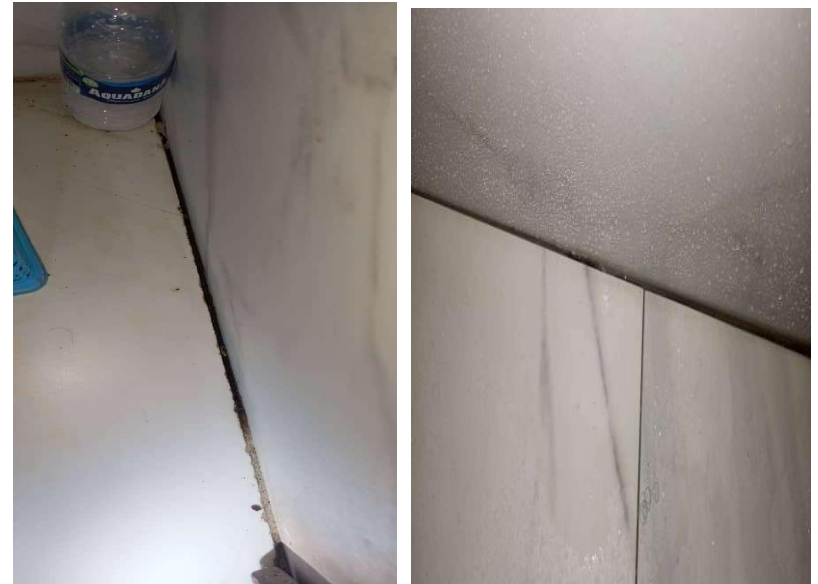
Pic showing: Toilet tiles that need proper grouting.

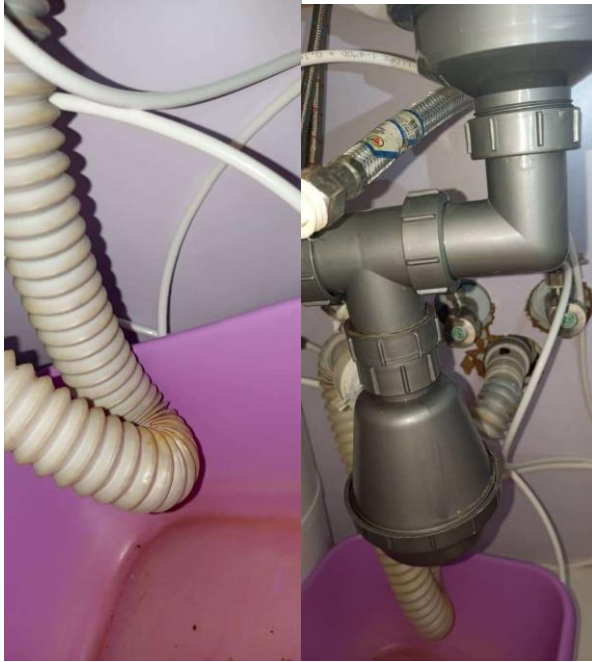
Pic showing: under-sink plumbing showing drainage connection and evidence of suspected leakage requiring plumbing repair.

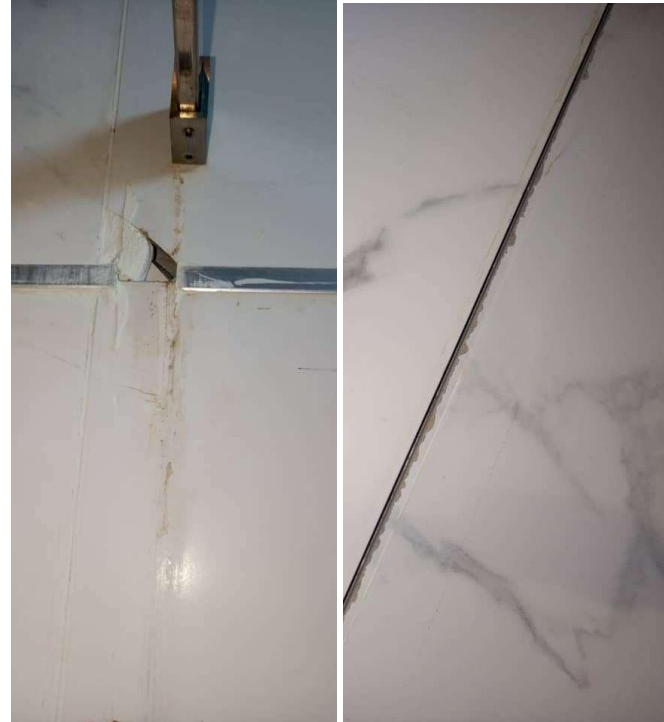
Pic showing: Displacement of Metal tile trim / divider.

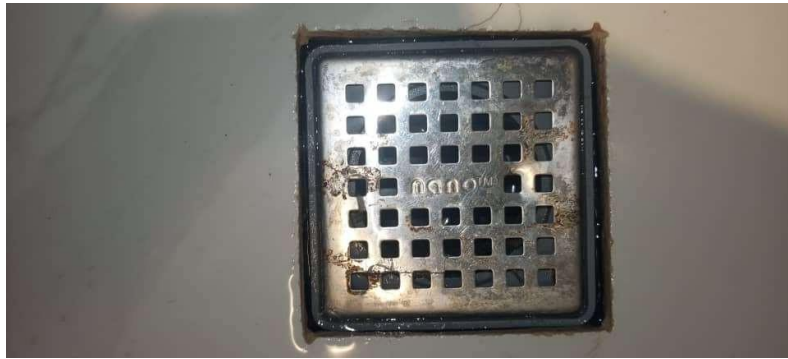
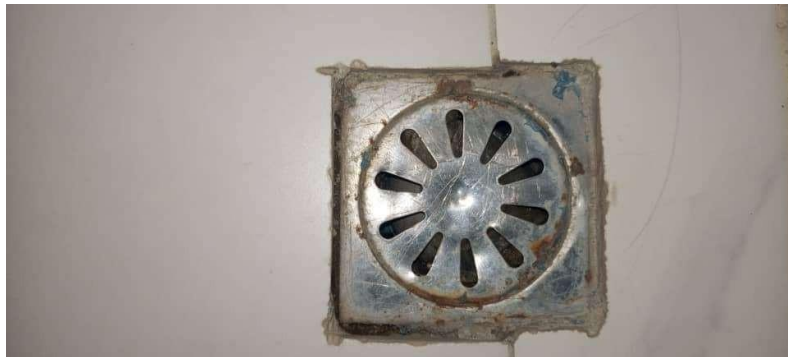
Pic Showing: Corroded floor drain with deteriorated sealant around the drain frame, indicating maintenance and resealing are required.

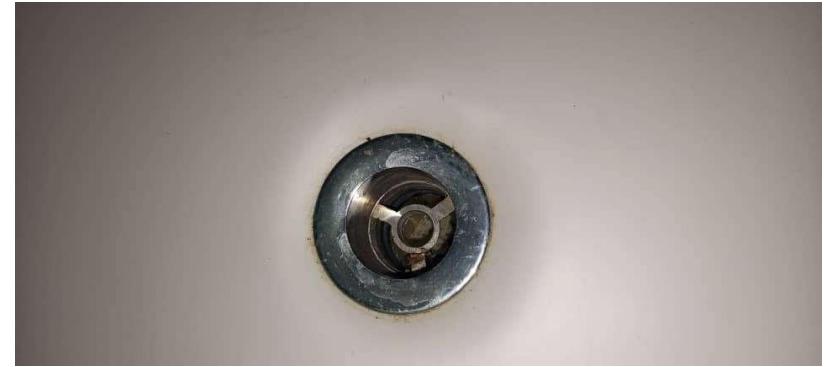
Pic Showing: Jacuzzi bath pressing no waste that needs to be replaced.

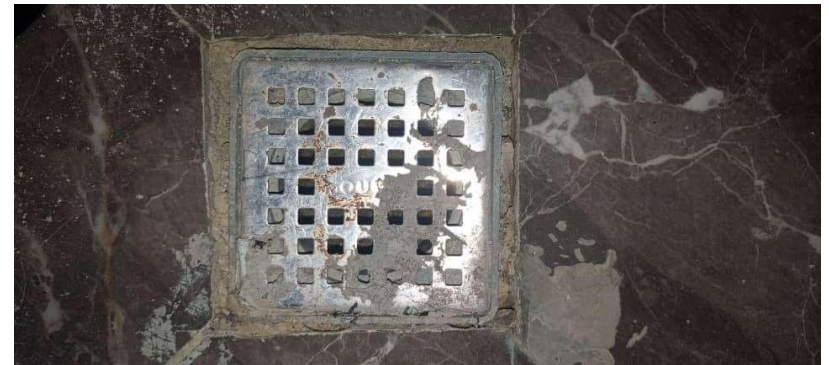
Pic Showing: Corroded floor drain with deteriorated sealant around the drain frame, indicating maintenance and resealing required.

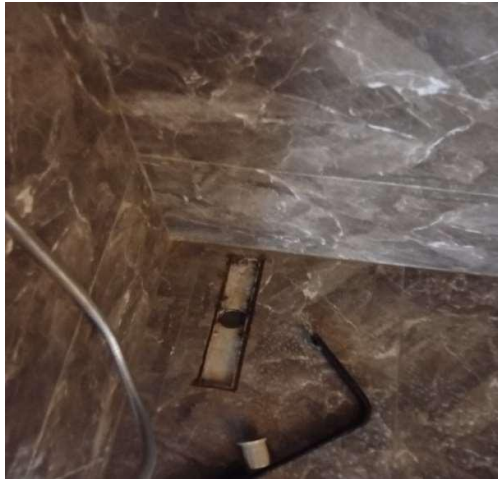
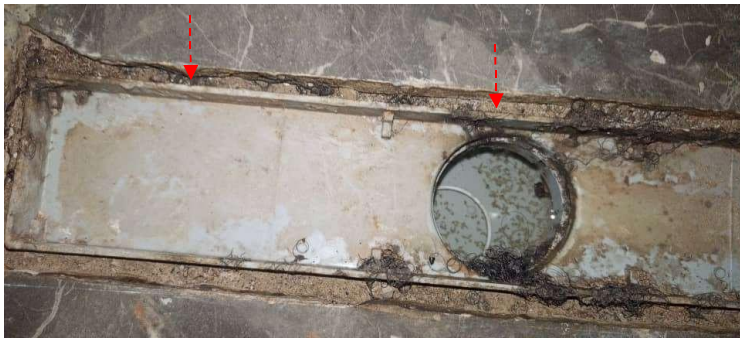
Pics showing the displaced drain outlet needing to be cleaned and sealed properly.

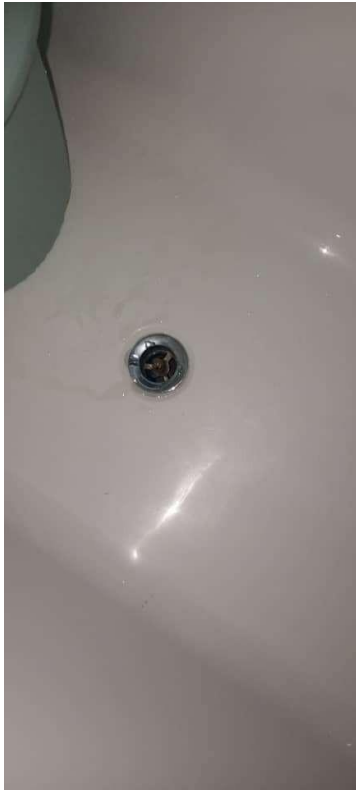
Pic Showing: failed sealant and evidence of water leakage observed around the jacuzzi side panel and drain outlet.

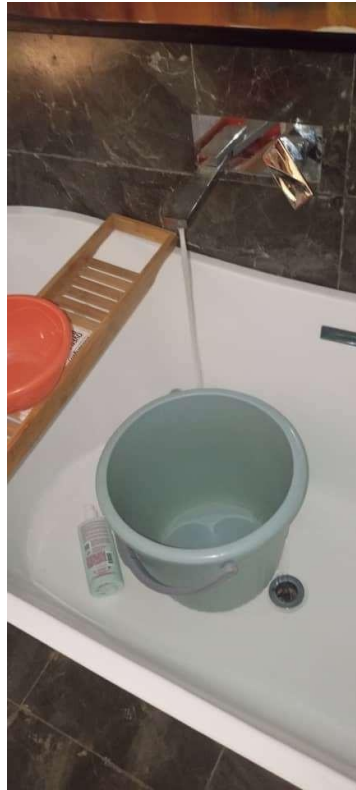
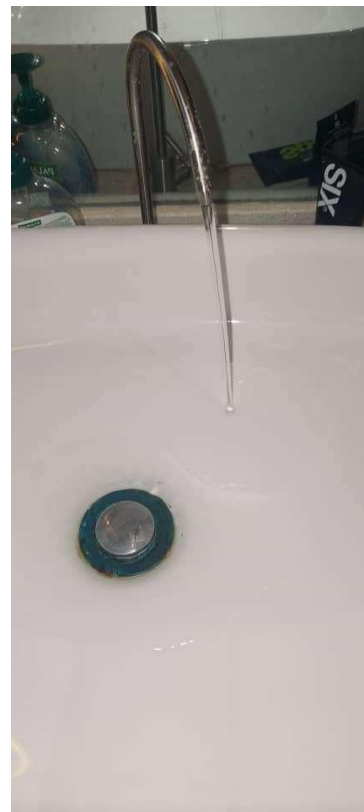
Pic Showing: Hand basin tap with low pressure.

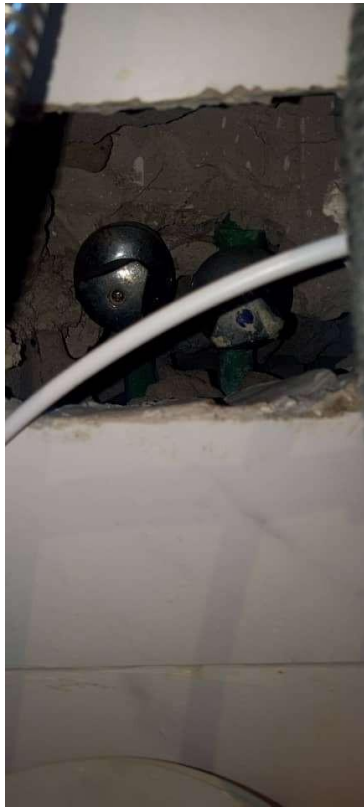
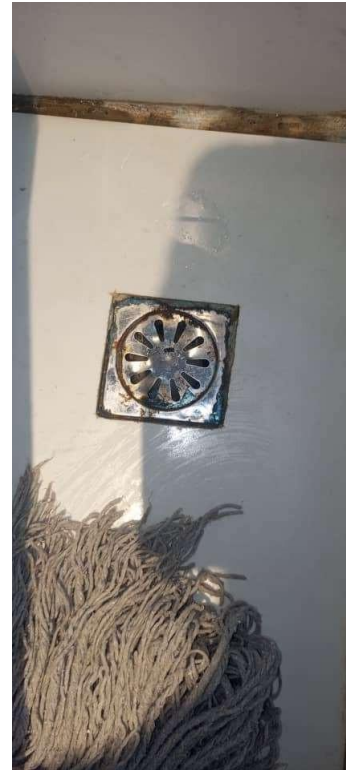
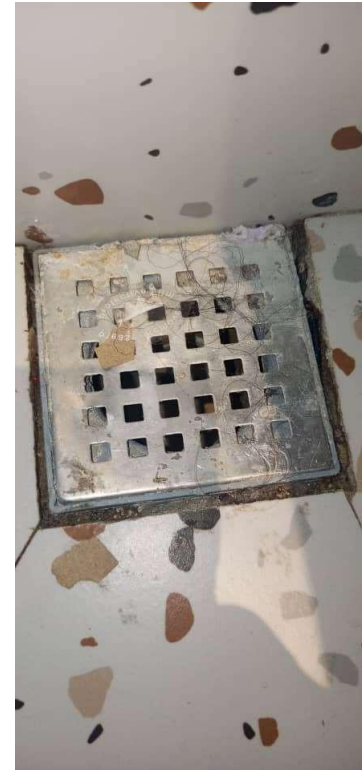
Pic showing: Corroded floor drain with deteriorated sealant around the drain frame, indicating maintenance and resealing required.

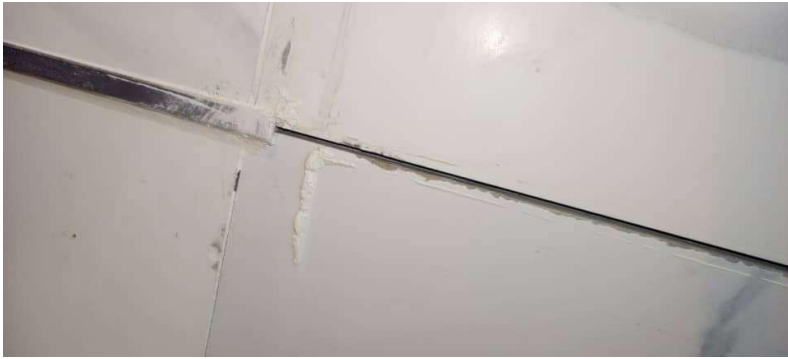
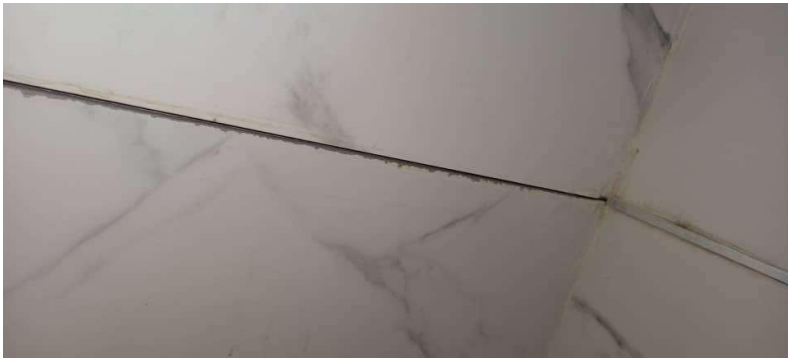
Pic showing: Displacement of Metal tile trim/divider.

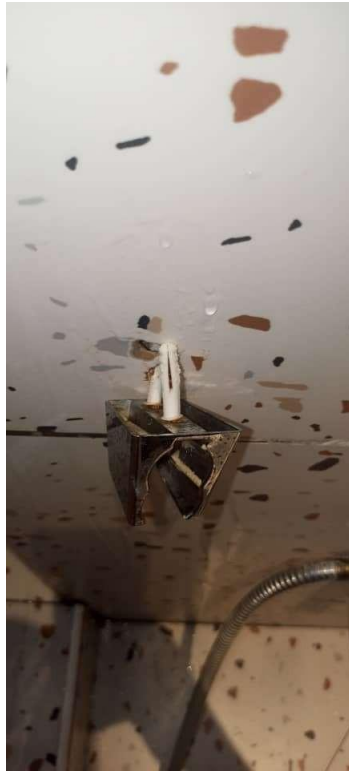
Pic showing: Hand shower hanger displaced, this should be properly fixed back to the wall to prevent future home hazards.

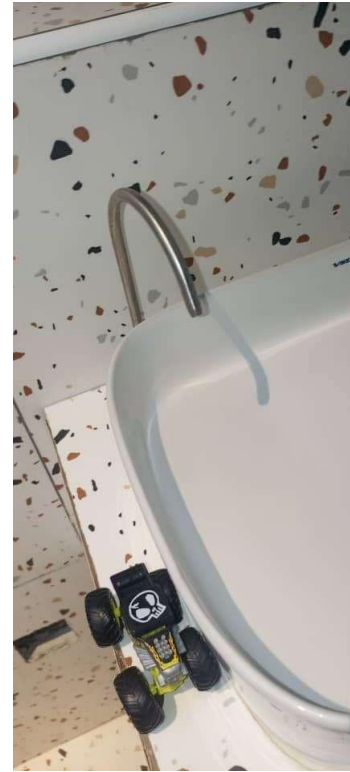
Pic showing: Tap of the washing hand basin not flowing, and floor tiles not properly grouted.

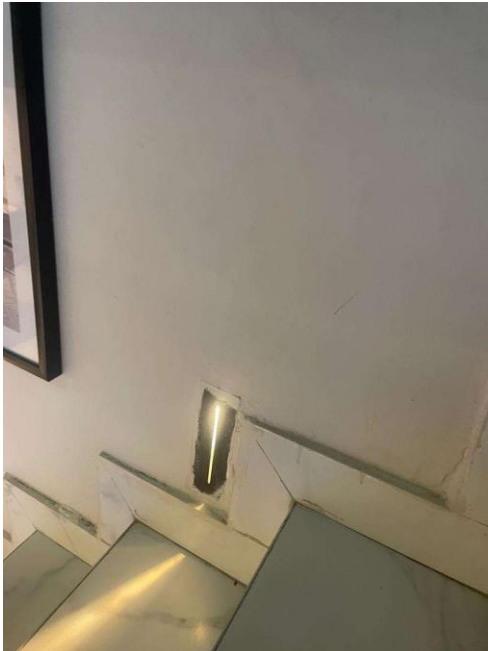
Picture Showing working step light

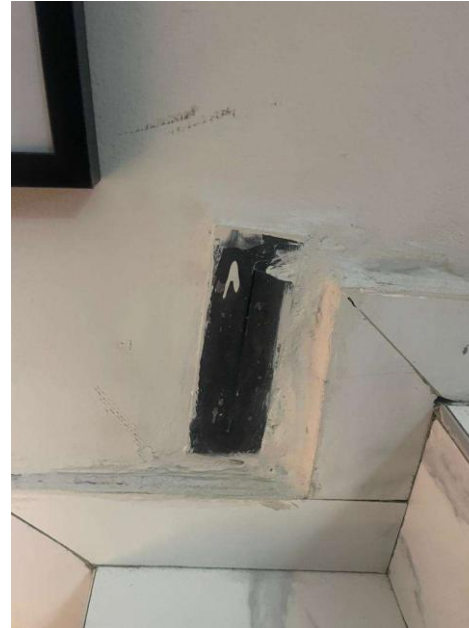
Picture showing damaged step light

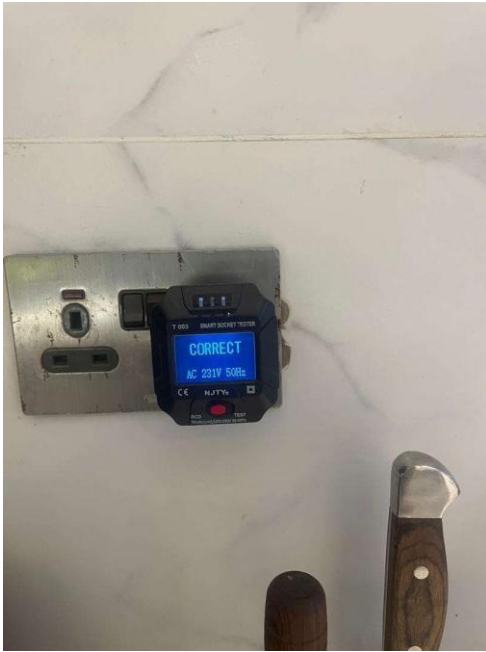
Picture showing correct voltages in the socket

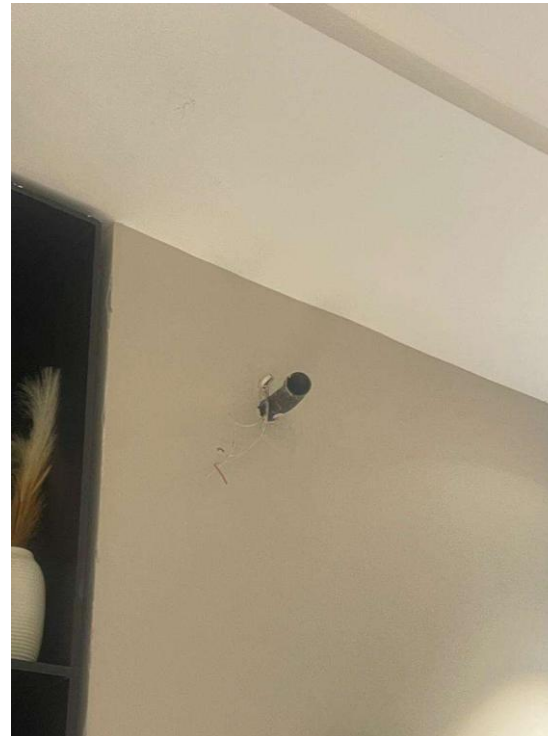
Picture showing an exposed cable intended for an air-conditioner in the office

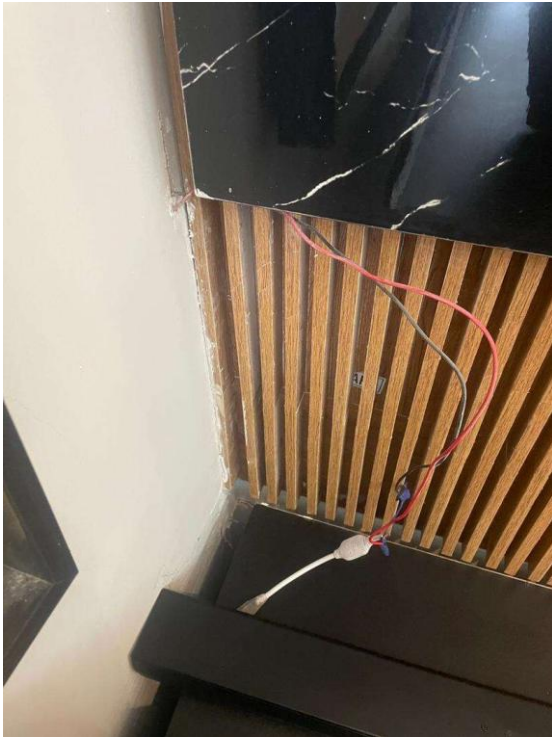
Picture showing an exposed cable for a proposed air-conditioner in the bedroom

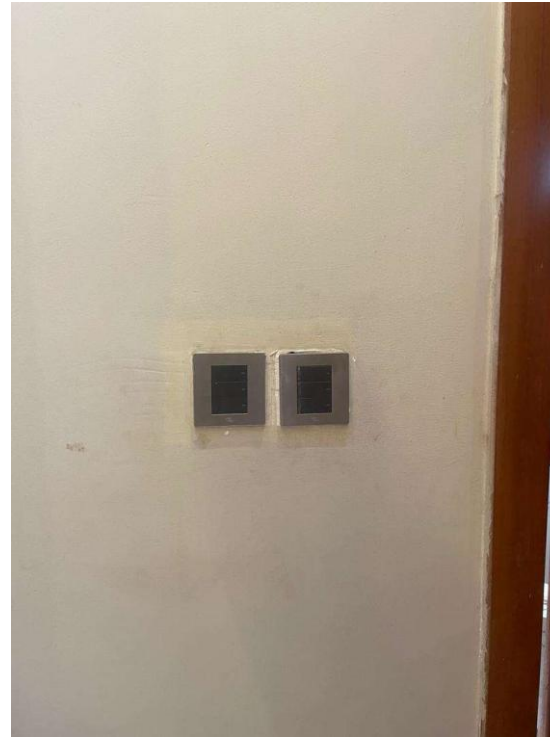
Picture showing aligned switches
